Building Facade Assessments and Recommendations

Building Façade Assessment Overview

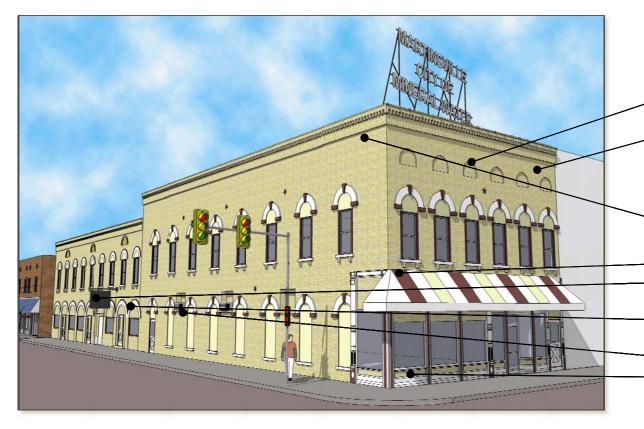
- Where there are attic openings, restore surviving original or recreate missing grilles and paint.
- Repair brick and mortar including cracks.
 - Option one: remove paint using nonabrasive method to protect old brick.
 - Option two: remove loose paint and repaint brick.
 Paint trim and face brick complimentary colors.
- Analyze structural condition of upper building façade. Repair cracks in brick.
- Remove awning that covers building details.
- Remove backlit plastic sign and install more appropriate façade or smaller hanging sign(s).
- Remove wood window infill and recreate clear glass storefront windows.
- Remove window air conditioners, infill square openings.
- Remove aluminum from bulkhead below storefront windows.

- Restore and relight the historic 'City of Mineral Water' sign on roof.
- Replace existing doors with historically accurate two panel, glass over lower kick panel doors.
- Repair existing wood storefront window frames and repaint. Install clear, energy efficient glass to fit within existing frames.
- Replace missing trees in tree grates along Main Street.
- Restore or recreate bulkhead.
- If desired, install fixed or operable canvas or mattefinish weather resistant cloth awning. Width of awning shall fit between column lines and should not extend the full width of the storefront. Awning valance shall not be fixed or rigid.

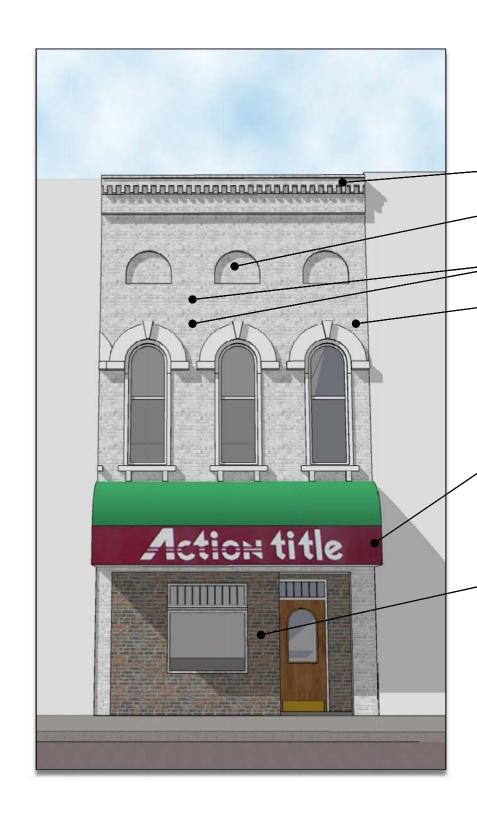
- Repaint or replace coping
- Remove plywood infill and install grilles with traditional pattern openings and bird screen behind grille.
- Remove old signage anchors; repair masonry.
- Remove paint with non-abrasive methods. Repair any loose masonry and mortar.

- Canopy style is not in keeping with style and proportion
 of historic canopy. Width of canopy would historically
 have fit within storefront column spacing and not extend
 across the entire width of building. Front valance should
 not be rigid or fixed. More appropriate canopy would be
 canvas or matte-finish weather proofed fabric.
- Remove modern brick façade and windows
- Install wood frame storefront and energy efficient glazing to match historic storefront detailing that would have maximized the glass. Use interior shades or drapes for privacy. Top of bulkhead below storefront glass should be no more than 30" above sidewalk grade.

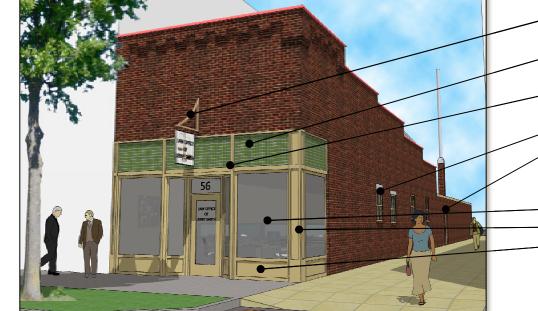
- Remove, clean, reset and seal existing clay coping tile.
- Clean and repoint brick.
- Remove existing hanging sign hardware.
- Repair brick where bolts are removed from brick and mortar.
- Replace metal flue on chimney.
 - Replace gutters and downspouts. If downspouts cannot be connected to city storm pipe, install boots at the base to direct water away from building.
 - Replace roof over door with inset doorway to provide a covered entrance without adding a roof structure.
- Remove wood infill from corner opening. Salvage any original transom glass or original storefront structure.
- Carefully remove wood and shingle awning and wood and brick storefront. Look for any original transom window glass or original storefront structure. Salvage and reuse all historic materials.
- Repair cementitious parge coating on base of building and repaint.

- New painted steel sign bracket with two sided hanging sign.
- New textured glass in transom. Glass color shall be clear or lightly tinted and allow filtered light into building.
- New wood window and door frame storefront inset slightly from iron corner posts.
- Open windows in alley to provide light to inner offices.
 Inset door, centered in storefront to provide covered entry that has an historic precedent in early 20th century commercial storefronts.
- New clear insulated storefront glass.
- Clean existing iron columns and paint.
- New wood bulkhead, height of bulkhead to match corner column base, approximately 20" above pavement.

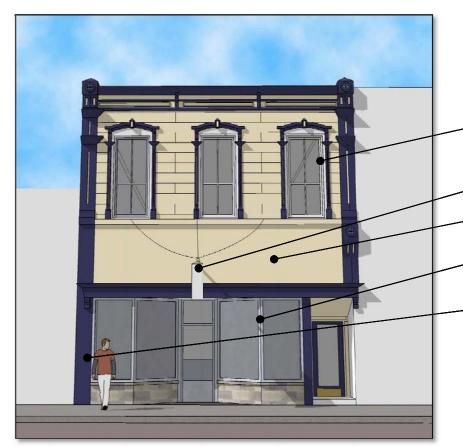
- Repair rotted wood window pieces, caulk and paint. Caulk perimeter of wood frames.
- Remove existing signage and hardware complete.
- Remove existing plywood infill panels.
- Remove existing aluminum window frames and single pane glass.
- Remove modern covering from column.

- Rebuild cornice to match historic cornice on the building to the east that was originally identical.
- Replicate original storefront with composite cement/wood frames and energy efficient glazing.
- Replace doors with wood frame doors that have historically accurate detailing and energy efficient glazing.
- Existing stone base can remain though it is not the original base. Optional composite cement/wood bulkhead below windows could be installed for a more historically accurate façade. Repaint columns, trim and storefront.
- Paint door and remove metal bars.

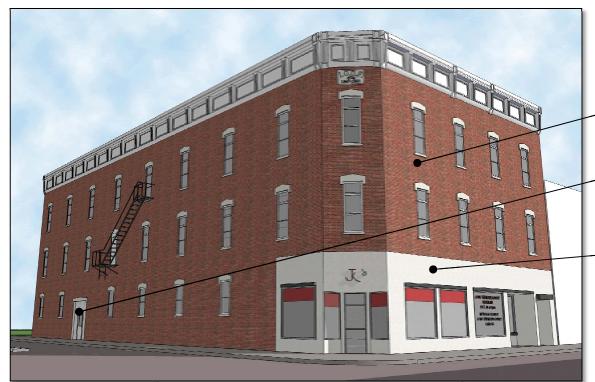
- Clean masonry to reduce visibility of previous mortar repairs.
- Replace cross buck door and wood siding with new doors to match new wood frame doors with energy efficient glazing.
- Remove existing plaster surfacing and open original transoms.

- Recreate original painted wood frame storefront with energy efficient glazing.
- Transom could be filled with energy efficient windows of clear glass to match new storefront frames.
- Install new wood frame doors with energy efficient glazing. Install pair of doors to match original historic door layout.

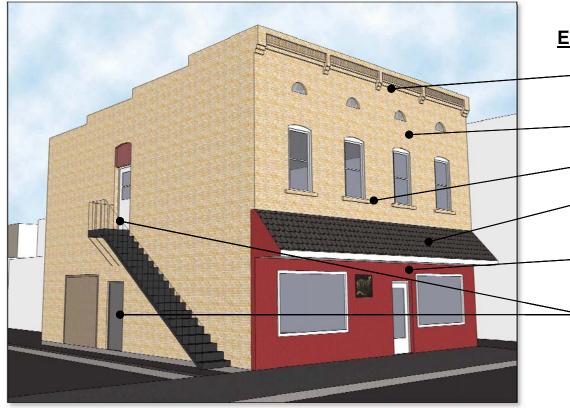
- Repair masonry cracks.
- Remove paint from brick using non-abrasive materials.
- Remove old sign hardware and hooks.
- Remove wood and asphalt awning that is inconsistent with original historic storefront.
- Remove existing wood façade and windows. Look for original storefront details and posts behind wood.
- Remove modern doors that do not match historic period details.

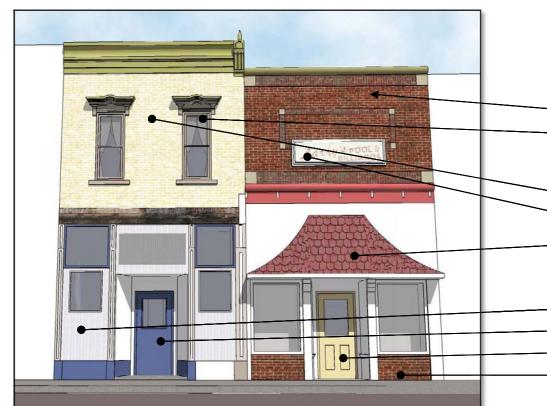
Existing Building Façade

Remove brick bulkhead below windows.

Repair and replace missing or loose mortar.

Repair wood window frames and paint.

Remove canopy and wood siding covering what were transom windows. Remove existing materials carefully and salvage all original transom frames if still in place. Remove wood infill panels and small glass panels.

Remove paint on brick using non-abrasive methods.

Remove plastic sign.

Remove existing metal door. Remove existing entrance door.

- Clean and paint upper metal cornice.
- Recreate lower metal cornice to match historic details.
- Repair cornice and paint.

- Repair wood storefront frames and modify to accept clear, energy efficient glass.
- Repair and paint existing cast iron columns. Replace missing details.
- Install new wood storefront frames and clear, energy efficient glass.
- Install new painted wood doors.
- Replace wood bulkhead below storefront.
 - Install new painted wood bulkhead below windows.

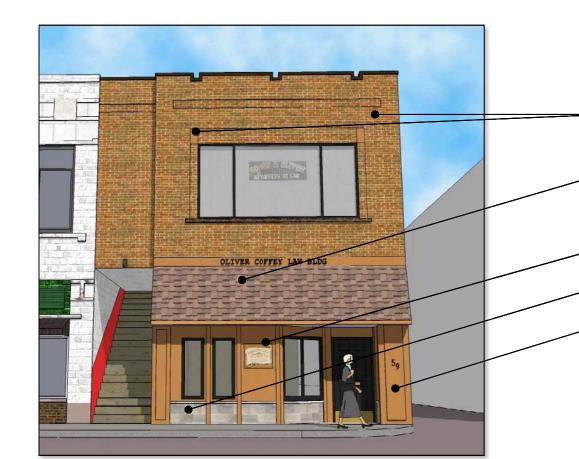
- Repair masonry mortar cracks; repoint to match existing mortar.
- Remove existing wood and shingle awning to reveal original transom window behind. Salvage and reuse any existing remaining textured glass.
- Remove wood siding and casement windows.
- Remove stone bulkhead below windows.
- Remove wood surrounding brick building columns at corners.

- Install textured glass transom to match historic condition.
- Install new painted wood storefront window and door framing with clear, energy efficient glass. Inset door for protection from weather. Use interior drapes or blinds for privacy.
- Repaint passage to second floor with color to match brick.
- Install painted wood bulkhead below storefront windows.
- Install new wood painted two panel door with glass above and wood below.
- Replace handrail in stairway. Repair lower wood steps.

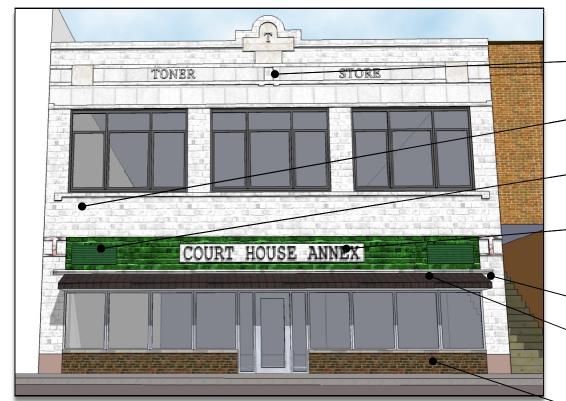
Existing Building Façade

- Inspect and repoint all existing joints between terra cotta pieces to ensure water tightness of the façade.
- Repair large cracks in existing terra cotta panels which may require fabrication of replacement pieces.
- Remove existing louvers; rework ductwork inside building to maintain fresh air requirements.
- Remove existing signage and wood siding. Protect any remaining textured glass transom below. Remove paint that is on terra cotta panels adjacent to the existing sign.
- Repair holes and miscellaneous cracks in terra cotta.
- Remove existing roll-up awning, repair frame, add new canvas or matte finish weather resistant material and reinstall.
- Remove brick bulkhead below windows and replace with dark granite panels to match existing base at each end of building. Salvage existing granite if still in place underneath brick.

- New hanging sign to comply with the Historic Downtown District ordinance.
- Salvaged or recreated textured glass transom. Repair holes left by louvers with matching glass tile.
- Repair or replicate blue glazed terra cotta letters that spelled 'Toner Store'.
- Restore decorative terra cotta detail to original condition.
- Existing storefront frames and glass may remain but if new energy efficient glass is installed, a darker color window frame should be installed.
- Install new dark granite panel bulkhead below storefront windows.

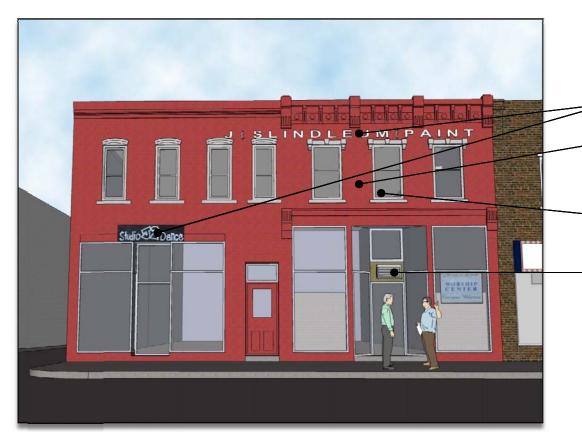
- Remove older signage.
- Remove paint from building including window sills and trim, repair loose brick and mortar. Remove paint with non-abrasive methods.
- Clean, caulk and paint windows. Caulk perimeter of wood frames.
- Remove window air conditioner and provide cooling using other means.

- Install new painted wood frame door with glass transom.
- Install new energy efficient clear glass. Install new sealant at all windows to prevent water from causing problems with masonry.
- Install stone bulkhead below storefront windows.
- Clean and repaint existing storefront columns and bulkhead.
- Install new wood frame storefront with energy efficient, clear glass.
- Repair existing wood door and paint. Replace missing mailbox slot in door.
- Remove concrete block bulkheads and replace with stone base.

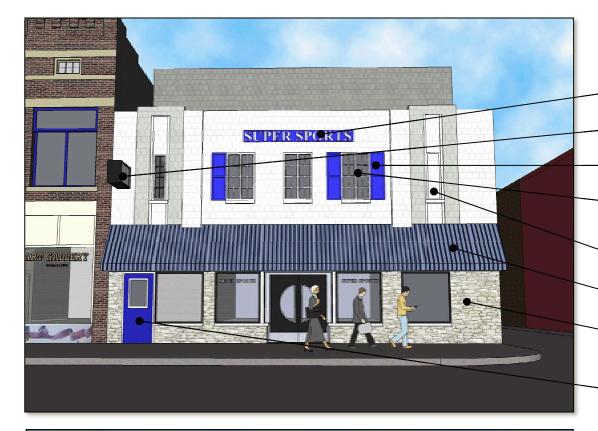
- Remove existing building signage.
 - Remove signage and electric conduit complete.
- Remove shutters.
- Clean, re-glaze broken or missing window glass, remove rust from steel window frames and repaint.
- Replace window glass.
- Remove existing awning and framework.
- Remove stone veneer that is not typical for older building façade material.
- Remove non-historic steel door.

- Install black glass tile to match 1939-40 façade.
- Paint horizontal bands to match historic façade.
- Paint window frames same color as building façade.
- Recreate aluminum theater type cornice and front overhang. Overhang can act to protect door and for business signage.
- Repair, repaint and reuse historic doors.
- New exterior materials to match original appearance.
- Install black glass tile bulkhead below storefront windows to match historic façade.
- Install new painted wood door with clear glass above solid kick plate.

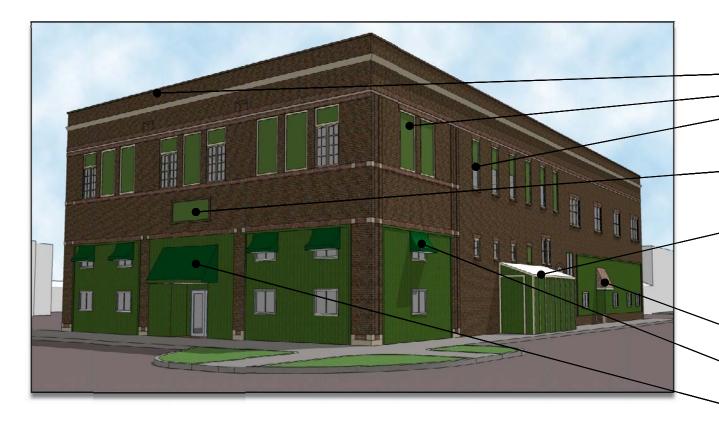
- Repoint joints between limestone pieces in coping.
- Remove wood infill panels from all windows.
- Repaint all window frames, caulk perimeter of all windows and openings.
- Remove painted metal panel over original 'Barskins' sign panel.
- Replace wood frame covering over areaway and replace with flush grating to improve pedestrian flow on sidewalk. Review potential of having access to basement area on inside of building so outside attached access can be removed.
- Remove canopy complete.
- Remove small awnings and small windows.
- Remove canopy complete.

- Install new windows that match the frame style and profile of the older existing windows. Install clear, energy efficient glass.
- Repoint brick where inappropriate mortar was used in the repair of the parapet wall.
- Install textured glass transoms to match original details.
- Install awnings that fit between the brick columns and below the glass transoms.
- Install new clear, energy efficient storefront windows to match original storefront. Use interior drapes or blinds for privacy in apartments. Interior window treatments shall be consistent in all windows.
- Install new painted two panel wood entrance doors with clear glass above and solid kick plate below.
- Install brick and limestone bulkhead below storefront windows to match original detailing.

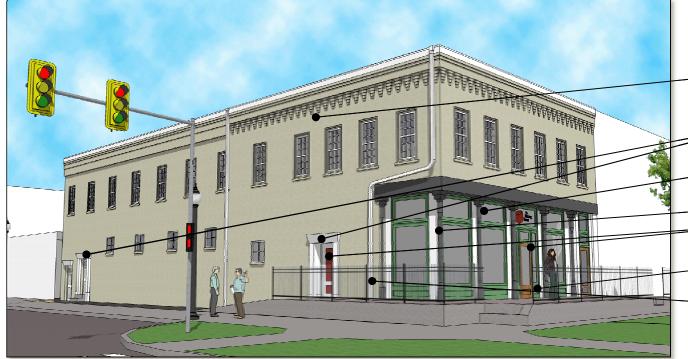
- Replace gutter and downspouts with new; rework details to be more historically accurate to early 20th century.
- Replace vinyl windows with custom windows that better fit the existing brick openings
- Remove large projecting sign and replace with smaller sign on transom.
- Remove old sign frame and hardware.
- Remove canopy that covers building details; create more historically accurate transom over storefront windows.
- Remove residential style pediment entrance around door.
- Open bricked over windows; install windows that are historically accurate to the age of the building.
- Remove and relocate building directory near building entrance or remove from building if no longer used.
- Remove aluminum cover from columns.
- Relocate exhaust fan to roof.

- Remove flaking paint from entire building. Repair loose parging, brick and mortar. Repair areas where moisture is entering brick; repaint building.
- Install simple cornice and door trim to match style of new storefront.
- Recreate painted wood storefront and install clear, energy efficient glass and transoms.
- Paint cast iron columns.
- Replace doors with clear panel glass over solid kick plate to replicate historically accurate door.
- Install new bulkheads below windows to match era of building.
- Install new ornamental painted railings.

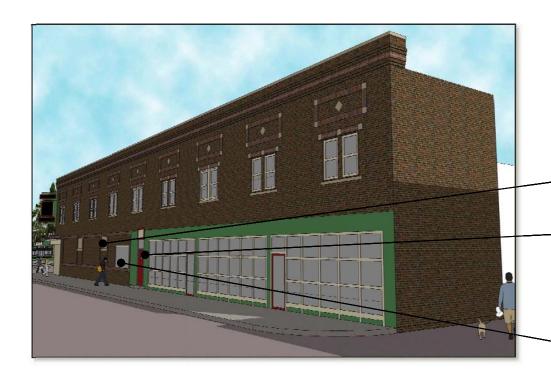
- Repair and reuse 1950 era sign.
- Remove existing canopy complete.
- Remove existing limestone infill panels and install new windows to match existing second floor windows.
- Remove existing wood siding and aluminum entrance doors.
- Remove existing wood siding enclosure around ← structural column.
- Remove painted wood infill panels.

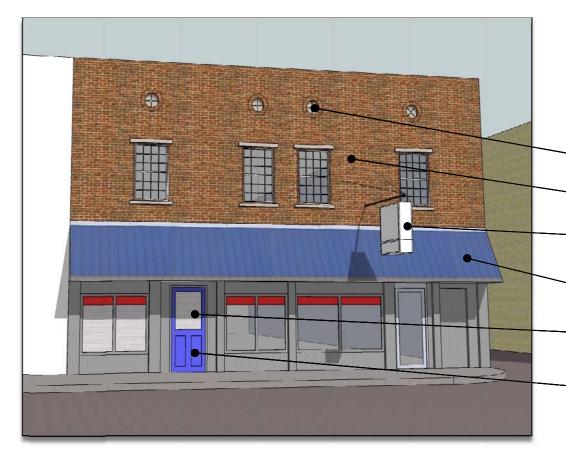
- Repair attic grilles and paint.
- Remove inappropriate mortar repairs and repoint brick.
- Replace internally lit sign with double face non-internally lighted projecting sign and new hardware.
- Remove canopy that covers building details.
- Remove air conditioner above door and install in more inconspicuous location or add central HVAC system.
- Remove period inappropriate doors and replace with new two-panel doors with energy efficient clear glass.
- Remove wood façade carefully. Save original columns and reuse in existing location to recreate architecturally accurate storefront.

- Restore original columns if they exist or install painted wood columns and window frames.
- New projecting sign with two sided text in scale with the building.
- Architectural interpretation of recreated storefront is based on the original, intact, storefront to the north.
- Install energy efficient, clear window glass.
- Install painted wood bulkhead below window to match the building to the north.
- Install new solid three panel painted wood door.
- If desired, install fixed or operable canvas or mattefinish weather resistant cloth awnings. Width of awning shall fit between column lines and should not extend the full width of the storefront. Awning valance shall not be fixed or rigid.
