75-77 East Washington Street

***In-depth Building Analyses and
Recommendations***

In-depth Building Analysis Overview

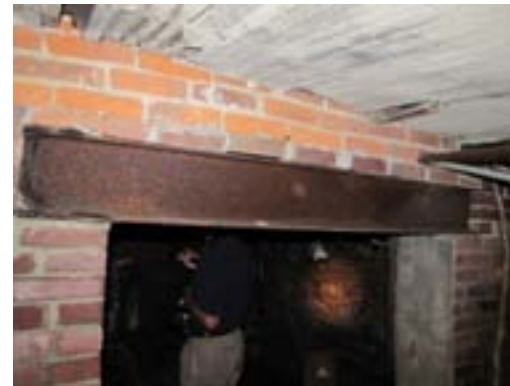
- There is a corroded steel lintel over the opening between the inner and outer basement rooms.

P8 – Corroded steel lintel over a basement wall opening.

- The collapsed walls in the basement and basement stairs need to be relayed and stabilized to provide a functioning retaining wall and provide proper joist support.
- The steel lintel over the basement wall opening should be removed and replaced. The opening can be reduced to require a shorter lintel.
- The roof framing over the west ‘L’ wing should be removed and replaced and all new decking and roofing be installed. The new roof can be profiled to accommodate the removal of the wood framed east wing.

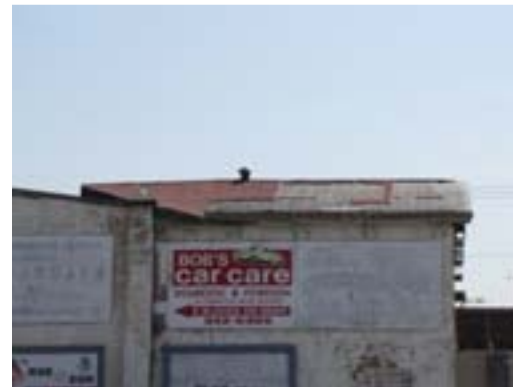
- Significant portions of the roofing over the rear wing, wood framed addition of the building are missing. This has likely resulted in water damage to the roof framing members and wood roof deck.

P12 – View of the west side of the rear addition. Note the missing roofing and the exposed wood deck on the gable portion of the roof.

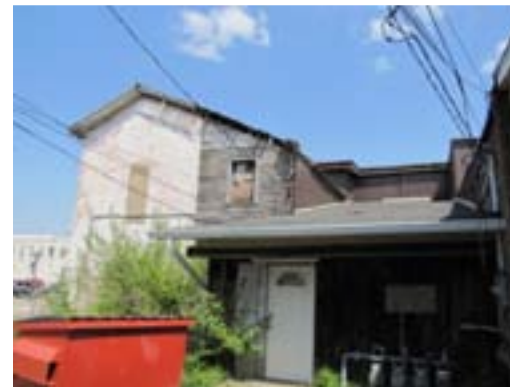
P13 – View of the rear of the building. Note the deterioration of the wood framed portion of the west wing addition.

- It is recommended that the wood wing of the building at the rear be completely demolished due to the poor and unsalvageable condition of the structure (see note regarding further structural study). This demolition will need to respect the one story jewelry store addition. The front wing and the west ‘L’ wing can then be rehabilitated and repaired for future usage.
- The overall strength and stability of the first floor needs to be reviewed and appropriate strengthening members put in place for retail loading. This will require a more in-depth structural study.

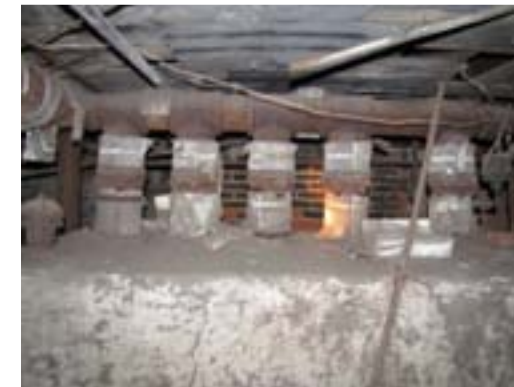
P14 – View of the abandoned boiler in the basement. May represent a hazardous material condition.

- The basement should be cleaned out and abandoned pipes and mechanical equipment removed to create a less hazardous basement area.
- The second floor of the brick wings of the building should be thoroughly analyzed for future residential occupancy loading.
- The roof framing over the front wing of the building should be checked for water damage and repaired as needed.

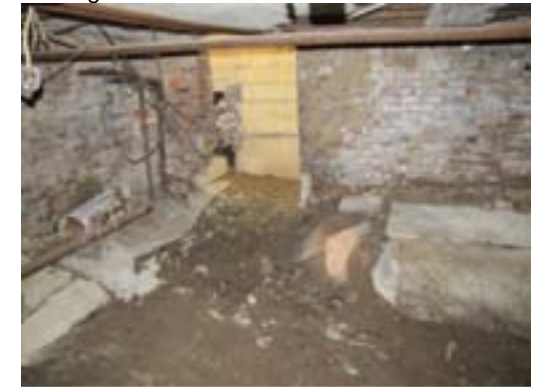
- The brick walls in the basement are in poor condition in many areas. The basement is very wet and the brick retaining walls have suffered partial collapse in a few locations.
- On one wall in the rear wing at the south east corner of the inner boiler room between the basement and crawlspace, the brick has collapsed to a significant degree. This appears to be causing severe sagging of the first floor directly over this area.
- There are structurally unstable areas of the retaining wall on the north and south sides of the exterior stairs leading to the

P15 – View of the basement looking south. Note the crumbling concrete at the base of the wall and the wet dirt floor.

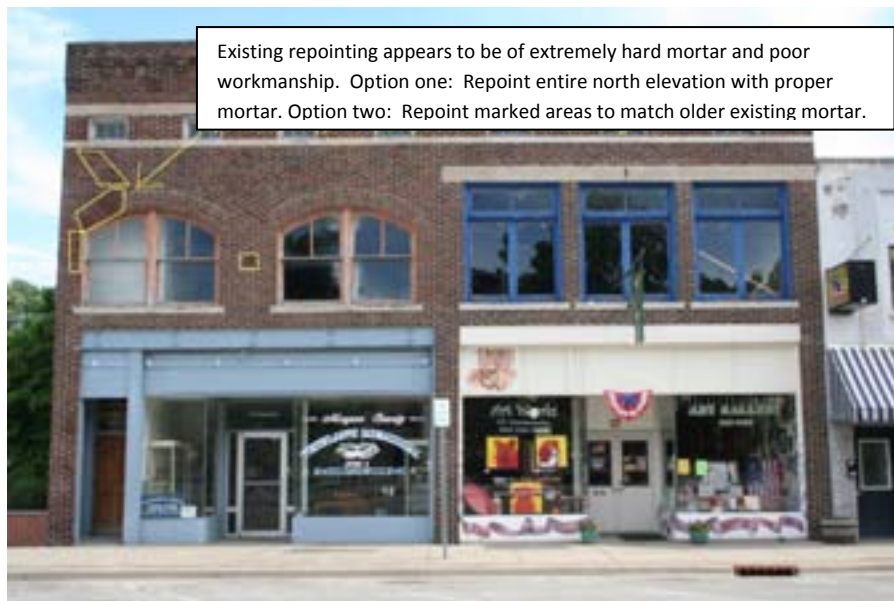
Existing repointing appears to be of extremely hard mortar and poor workmanship. Option one: Repoint entire north elevation with proper mortar. Option two: Repoint marked areas to match older existing mortar.

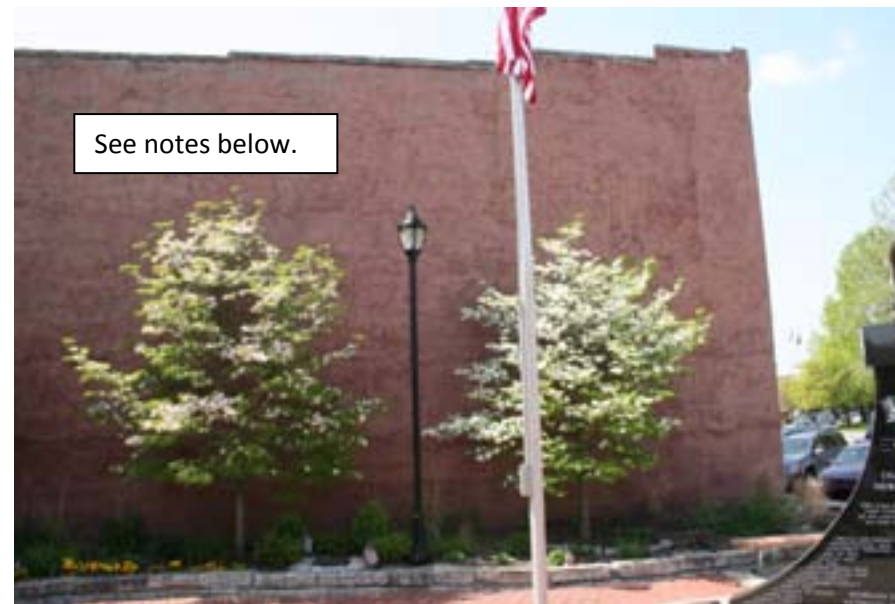
East Elevation

Note: There are two major factors that need addressed at the east building wall.

The moisture from the planter will cause damage to the floor joists that are embedded into the exterior masonry wall.

1. The landscape material should not come in contact with the building, and the drainage from the planters must drain away from the wall. Remove branches that contact wall. Install perforated drain tile along wall for positive drainage away from wall.
2. The plaster along the east wall is cracking and delaminating. The most economical approach to repair wall surface is to mechanically reattach the plaster and install a 1 to 1-1/2 inch EIFS over the existing plaster. *See the definition of EIFS in the Façade Assessment & Improvement Recommendations Overview, page 43.* Install a new metal coping at the top of the parapet wall.

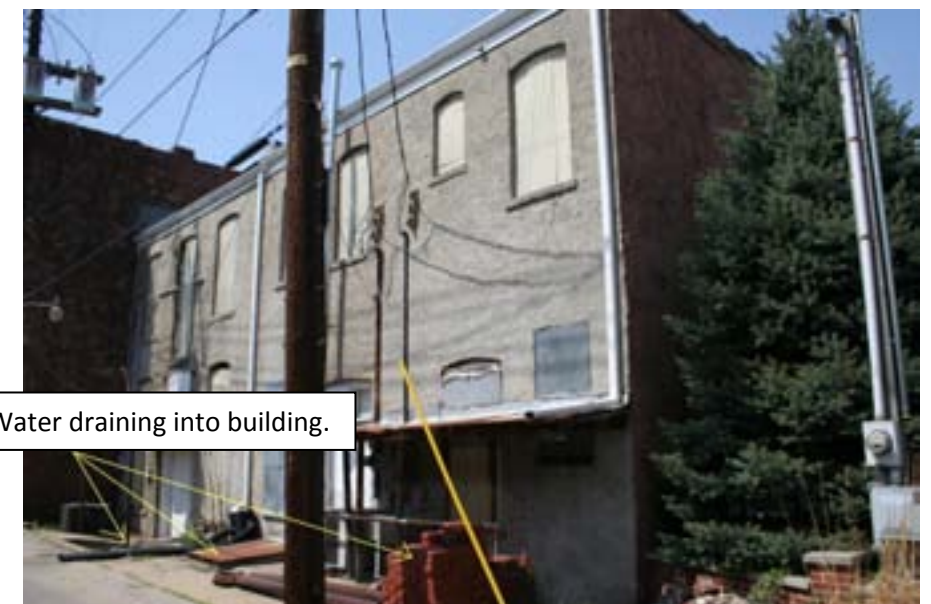
Water draining into building.

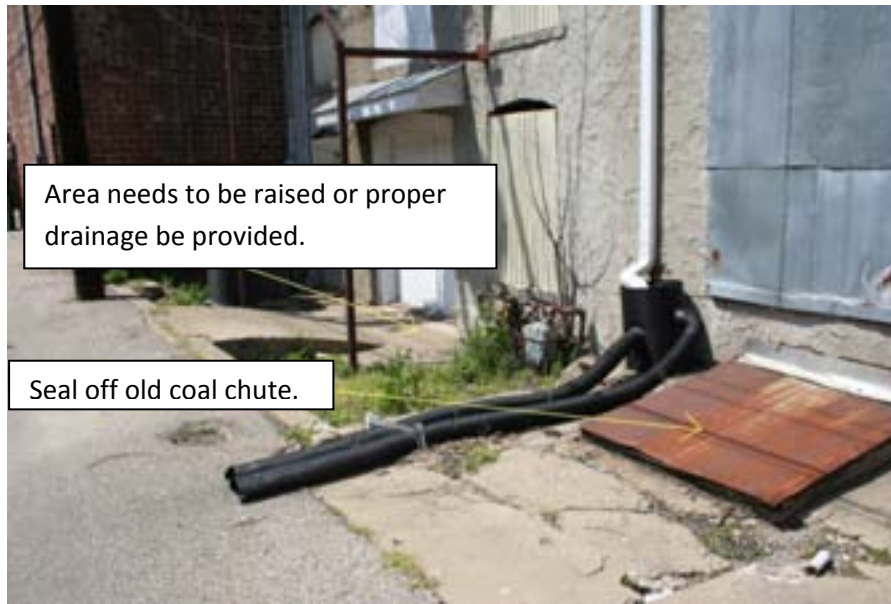
Area needs to be raised or proper drainage be provided.

The plaster along the south wall is cracking and delaminating. The most economical approach to repair wall surface is to mechanically reattach the plaster and install a 1 to 1-1/2 inch EIFS over the existing plaster. *See the definition of EIFS in the Façade Assessment & Improvement Recommendations Overview, page 43.* Install a new metal coping at the top of the parapet wall.

Seal off old coal chute.

Repair improper drainage in alley by removing old coal chute and raising finish grade near building to shed storm water away from building. Either connect downspout drains to city storm sewer system or direct water to street and away from building foundations. Remove exterior stair to basement and fill opening in foundation. Waterproof entire below grade wall before backfilling. Install new stair to basement inside building.

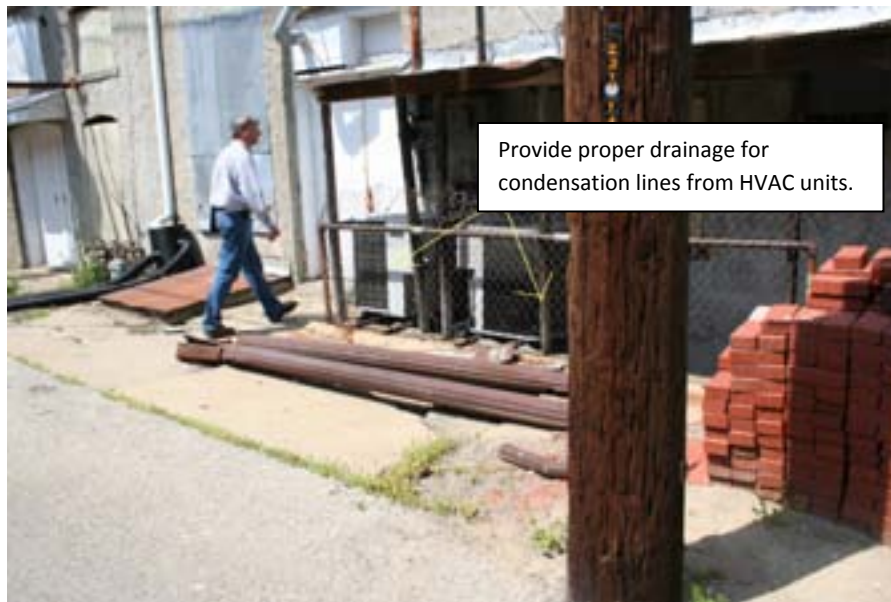
Provide proper drainage for condensation lines from HVAC units.

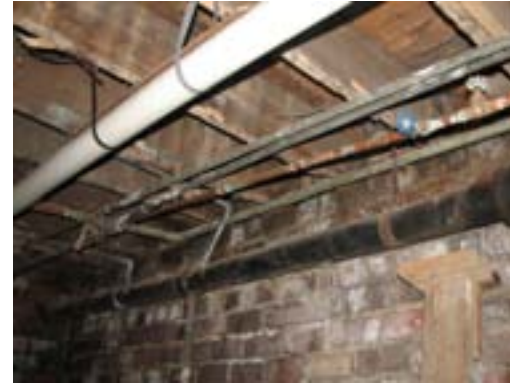
- The east ends of some joists under the VM were water damaged. The first floor of the VM was bouncy and not level in the rear room of the space. The front was less bouncy.

P3 – View of water damaged joists along the east side of the Veterans Museum first floor.

- The low finish grade in the rear of the building is contributing to water leakage in the basement. This condition should be studied and corrected as soon as possible to prevent further water leakage in the basement. The stair leading to the basement on the museum side of the building and the abandoned coal chute on the art store side should be closed off and filled in to eliminate this point of entry for water leakage. An access stair to the basement from the VM should be built internally.
- The wood beam supporting the first floor joists in the VM should be modified and intermediate steel jack posts added to increase structural floor capacity to 100 psf.
- The water damaged joists at the first floor of the VM should be removed and replaced.

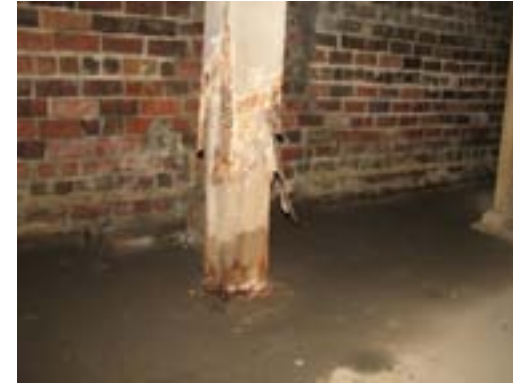
- The wood posts under the art store and VM are subject to water damage at the bottom due to basement water leakage.

P4 – View of the base of a wood post under the first floor of the Veterans Museum. Note the water damage.

- The wood posts in the basement under the art store and VM should be protected from water damage by installing a masonry or concrete pier under the wood posts to elevate them off of the wet basement floor.

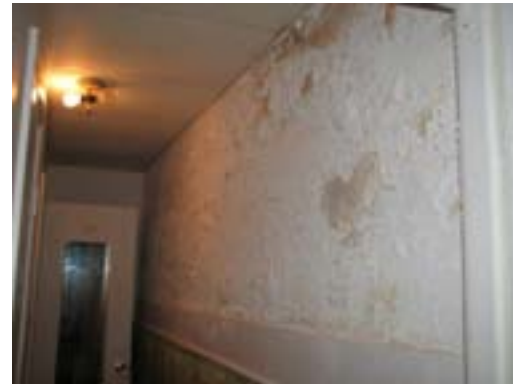
P7 – View of the inside of the east wall of the Veterans Museum. Note the peeled paint due to water leakage.

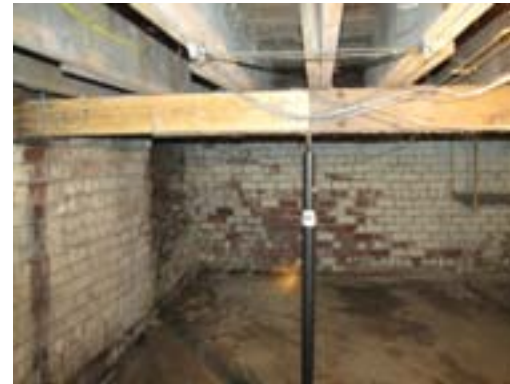
- Under the art store, some new steel jack columns have been added to help support the wood beams along the mid-span of the joists in the basement. This work was apparently done based on recommendations made in a previous report on this building.

- The existing wood beam under the art store has had some recent repair modifications, likely recommended in the prior report. The floor load capacity is at least 100 psf with the modifications that have been previously made. This is adequate for retail occupancy.

P8 – View of beam repairs and a new steel jack column in the basement under the art store.

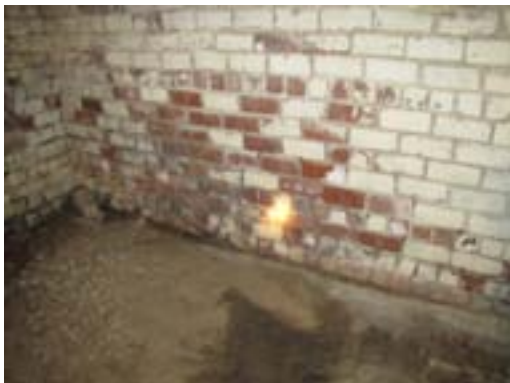
- The brick walls in the basement under the art store and VM are in fair condition but appear to have suffered the effects of past water leakage, especially along the rear wall on the south side. The basements are apparently damp to wet at times.

P11 – View of the basement wall under the art store looking southwest. Note the water damage to mortar joints.

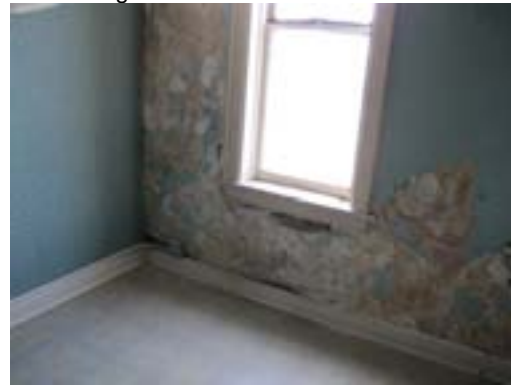
- There was noticeable water leakage and some masonry damage on the inside of the rear, upper exterior wall. This wall bears on a steel beam as described above. The water leakage appears to be the result of roof leaks and leaks around the windows.

P8 - Upper level exterior masonry wall at the rear of the two story wing. Note the water damage to the inside face of the wall.

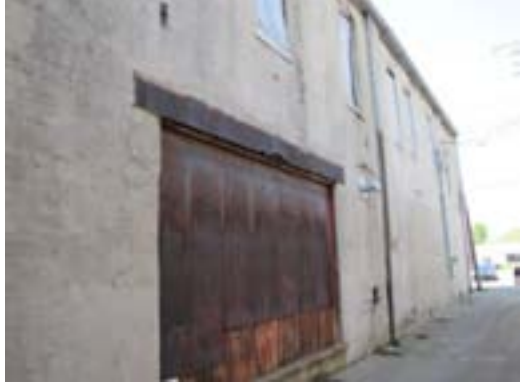
- There is one large opening at the first level on the north side with a corroded steel lintel over the opening.
- There is a modern wood framed awning over the east storefront.

P2 - Opening on the north side of the building. This opening should be filled with new concrete block. Note the corroded lintel.

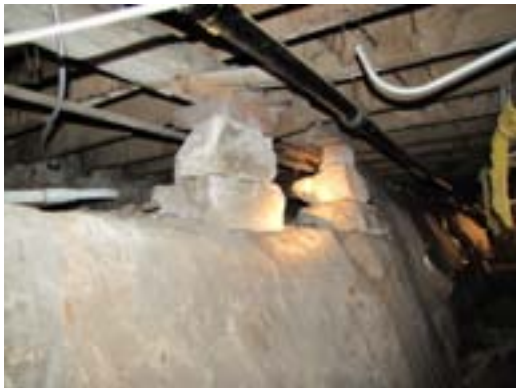
P6 - Stone and wood shim joist support on either side of the dirt basement tunnel. Note loose laid stone units.

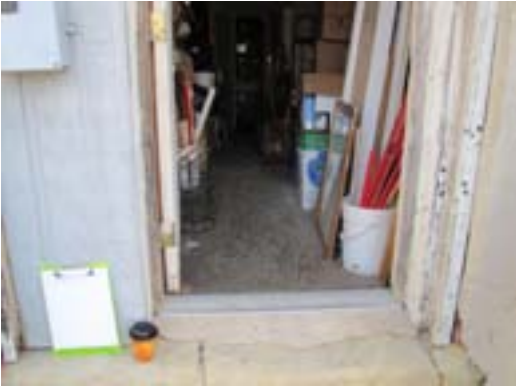
P10 - The floor just inside this rear door opening is very soft due to structural deterioration.

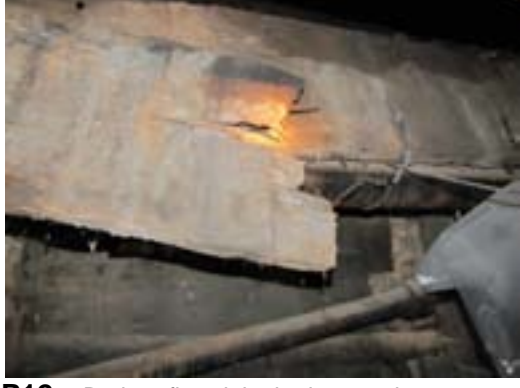
P12 - Broken floor joist in the rear basement compartment.
