Building Facade Assessments and Recommendations

Building Façade Assessment Overview

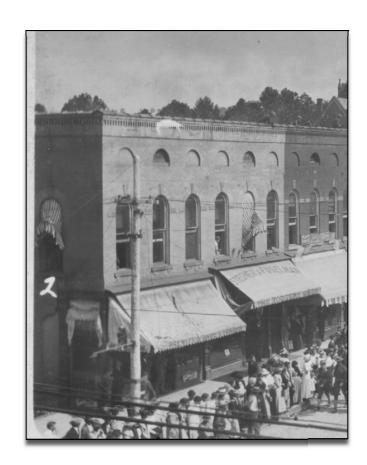
c. 1912 photo of 10 East Morgan exhibits most of the details that currently are evident on the existing building. 100 years ago, the brick was not painted and the awnings were the more traditional operable canvas type that fit below the building cornice.

- Where there are attic openings, restore surviving original or recreate missing grilles and paint.
- Repair brick and mortar including cracks.
 - Option one: remove paint using nonabrasive method to protect old brick.
 - Option two: remove loose paint and repaint brick.
 Paint trim and face brick complimentary colors.
- Analyze structural condition of upper building façade. Repair cracks in brick.
- Remove awning that covers building details.
- Remove backlit plastic sign and install more appropriate façade or smaller hanging sign(s).
- Remove wood window infill and recreate clear glass storefront windows.
- Remove window air conditioners, infill square openings.
- Remove aluminum from bulkhead below storefront windows.

- Restore and relight the historic 'City of Mineral Water' sign on roof.
- Replace existing doors with historically accurate two panel, glass over lower kick panel doors.
- Repair existing wood storefront window frames and repaint. Install clear, energy efficient glass to fit within existing frames.
- Replace missing trees in tree grates along Main Street.
- Restore or recreate bulkhead.
- If desired, install fixed or operable canvas or mattefinish weather resistant cloth awning. Width of awning shall fit between column lines and should not extend the full width of the storefront. Awning valance shall not be fixed or rigid.

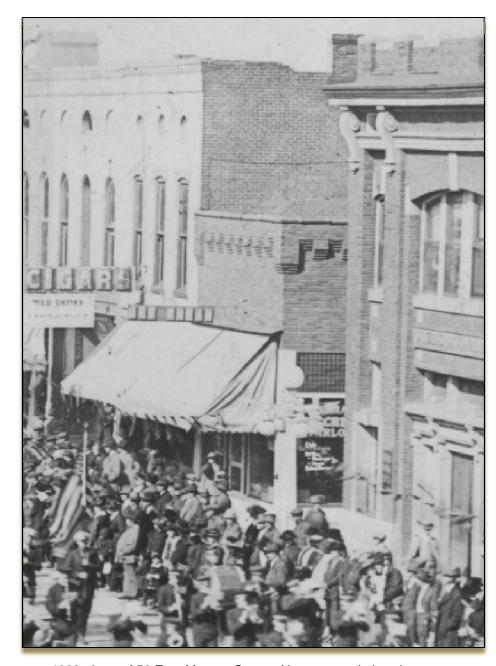
c. 1922 photo of 56 East Morgan Street. Note textured glass in transom above windows facing the alley.

- Remove, clean, reset and seal existing clay coping tile.
- Clean and repoint brick.
- Remove existing hanging sign hardware.
- Repair brick where bolts are removed from brick and mortar.
- Replace metal flue on chimney.
 - Replace gutters and downspouts. If downspouts cannot be connected to city storm pipe, install boots at the base to direct water away from building.
 - Replace roof over door with inset doorway to provide a covered entrance without adding a roof structure.
- Remove wood infill from corner opening. Salvage any original transom glass or original storefront structure.
- Carefully remove wood and shingle awning and wood and brick storefront. Look for any original transom window glass or original storefront structure. Salvage and reuse all historic materials.
- Repair cementitious parge coating on base of building and repaint.

- New painted steel sign bracket with two sided hanging sign.
- New textured glass in transom. Glass color shall be clear or lightly tinted and allow filtered light into building.
- New wood window and door frame storefront inset slightly from iron corner posts.
- Open windows in alley to provide light to inner offices.
 Inset door, centered in storefront to provide covered entry that has an historic precedent in early 20th century commercial storefronts.
- New clear insulated storefront glass.
- Clean existing iron columns and paint.
- New wood bulkhead, height of bulkhead to match corner column base, approximately 20" above pavement.

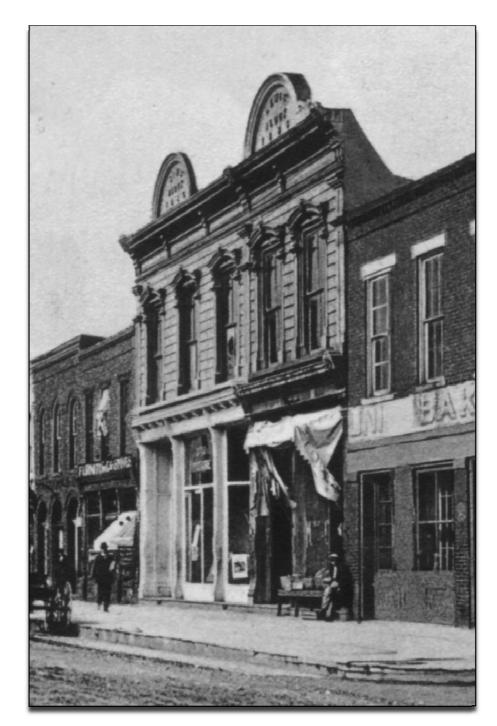
This c. 1910 photo of 78 East Morgan shows rounded architectural elements along the top parapet walls which are no longer in place. This proposal does not replace those elements due to lack of architectural details and anticipated cost to reproduce.

- Repair rotted wood window pieces, caulk and paint. Caulk perimeter of wood frames.
- Remove existing signage and hardware complete.
- Remove existing plywood infill panels.
- Remove existing aluminum window frames and single pane glass.
- Remove modern covering from column.

- Rebuild cornice to match historic cornice on the building to the east that was originally identical.
- Replicate original storefront with composite cement/wood frames and energy efficient glazing.
- Replace doors with wood frame doors that have historically accurate detailing and energy efficient glazing.
- Existing stone base can remain though it is not the original base. Optional composite cement/wood bulkhead below windows could be installed for a more historically accurate façade. Repaint columns, trim and storefront.
- Paint door and remove metal bars.

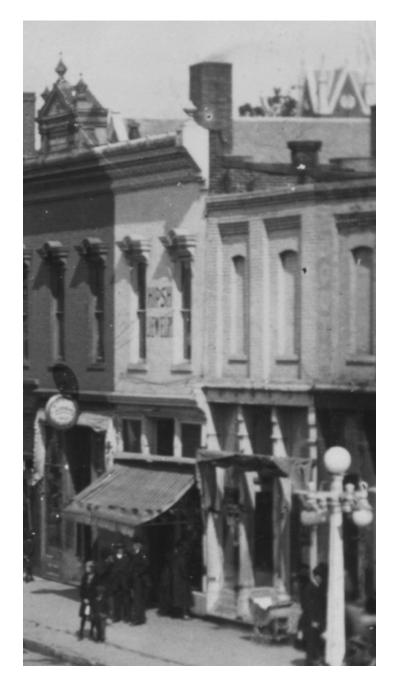
This c. 1922 photo shows that the upper level of 27 North Jefferson, the building to the right of Hipsh Jewelry, has been significantly altered and the upper windows removed. While it might be nice to recreate the upper windows, the current upper building façade retains some historic precedent of its own and should not be changed.

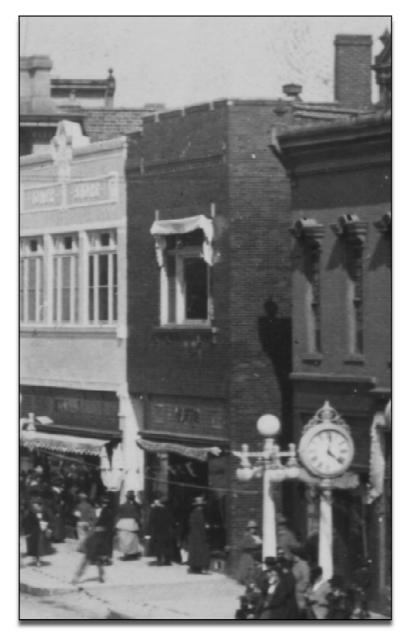
This c. 1922 photo shows that the upper window layout of the building has changed but the brick surround has remained intact. The lower part of the building is indicative of other commercial store fronts of the time with small pane textured glass transom and large clear storefront windows. Note ornamental street clock in foreground.

- Repair masonry mortar cracks; repoint to match existing mortar.
- Remove existing wood and shingle awning to reveal original transom window behind. Salvage and reuse any existing remaining textured glass.
- Remove wood siding and casement windows.
- Remove stone bulkhead below windows.
- Remove wood surrounding brick building columns at corners.

- Install textured glass transom to match historic condition.
- Install new painted wood storefront window and door framing with clear, energy efficient glass. Inset door for protection from weather. Use interior drapes or blinds for privacy.
- Repaint passage to second floor with color to match brick.
- Install painted wood bulkhead below storefront windows.
- Install new wood painted two panel door with glass above and wood below.
- Replace handrail in stairway. Repair lower wood steps.

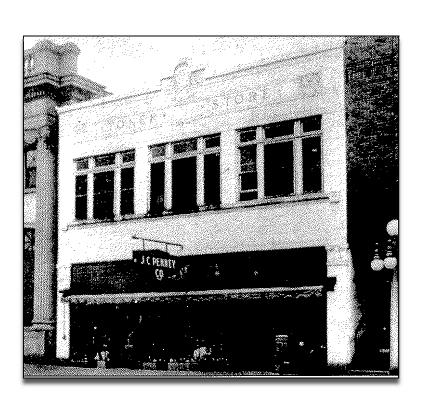
TONER STORE

The c. 1926 photo of the Toner Building below indicates that there was a textured glass or glass tile transom that included the words 'Toner Building' within the glass. While the Toner brothers and business have long since disappeared, the historic glass and building name is important to the history of downtown and should be saved and repaired.

- Inspect and repoint all existing joints between terra cotta pieces to ensure water tightness of the façade.
- Repair large cracks in existing terra cotta panels which may require fabrication of replacement pieces.
- Remove existing louvers; rework ductwork inside building to maintain fresh air requirements.
- Remove existing signage and wood siding. Protect any remaining textured glass transom below. Remove paint that is on terra cotta panels adjacent to the existing sign.
- Repair holes and miscellaneous cracks in terra cotta.
- Remove existing roll-up awning, repair frame, add new canvas or matte finish weather resistant material and reinstall.
- Remove brick bulkhead below windows and replace with dark granite panels to match existing base at each end of building. Salvage existing granite if still in place underneath brick.

- New hanging sign to comply with the Historic Downtown District ordinance.
- Salvaged or recreated textured glass transom. Repair holes left by louvers with matching glass tile.
- Repair or replicate blue glazed terra cotta letters that spelled 'Toner Store'.
- Restore decorative terra cotta detail to original condition.
- Existing storefront frames and glass may remain but if new energy efficient glass is installed, a darker color window frame should be installed.
- Install new dark granite panel bulkhead below storefront windows.

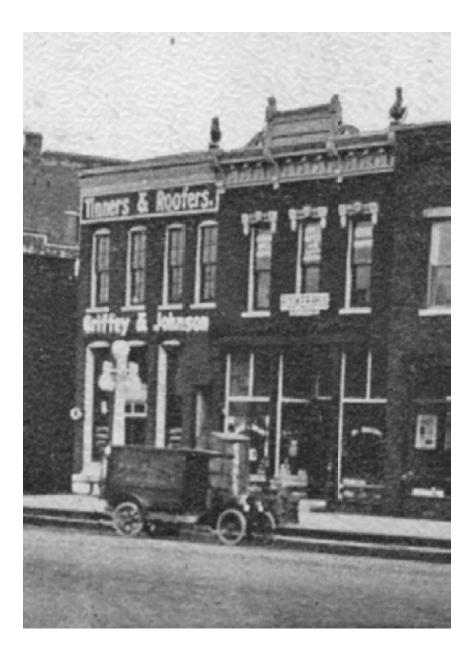
This c. 1916 photo shows that the façade on 29 East Washington has been significantly changed. Brick columns separated the 3 bays of the façade. These brick columns have been removed but the larger storefront windows and open transoms are still in keeping with the age and scale of the building, so new brick columns have not been proposed.

- Remove older signage.
- Remove paint from building including window sills and trim, repair loose brick and mortar. Remove paint with non-abrasive methods.
- Clean, caulk and paint windows. Caulk perimeter of wood frames.
- Remove window air conditioner and provide cooling using other means.

- Install new painted wood frame door with glass transom.
- Install new energy efficient clear glass. Install new sealant at all windows to prevent water from causing problems with masonry.
- Install stone bulkhead below storefront windows.
- Clean and repaint existing storefront columns and bulkhead.
- Install new wood frame storefront with energy efficient, clear glass.
- Repair existing wood door and paint. Replace missing mailbox slot in door.
- Remove concrete block bulkheads and replace with stone base.

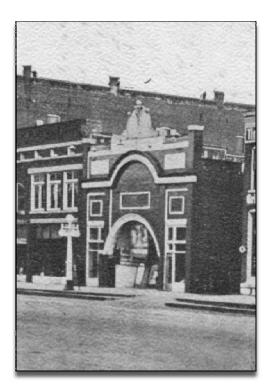
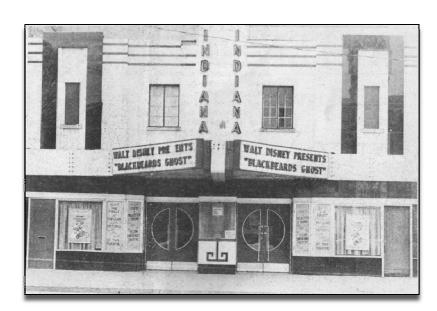
The above c. 1916 photo bears little resemblance to the later 1939-40 renovation shown in the photo below. Many of the 1939-40 building details are still recognizable, and it's this time period and detail recommended for façade renovations.

- Remove existing building signage.
 - Remove signage and electric conduit complete.
- Remove shutters.
- Clean, re-glaze broken or missing window glass, remove rust from steel window frames and repaint.
- Replace window glass.
- Remove existing awning and framework.
- Remove stone veneer that is not typical for older building façade material.
- Remove non-historic steel door.

- Install black glass tile to match 1939-40 façade.
- Paint horizontal bands to match historic façade.
- Paint window frames same color as building façade.
- Recreate aluminum theater type cornice and front overhang. Overhang can act to protect door and for business signage.
- Repair, repaint and reuse historic doors.
- New exterior materials to match original appearance.
- Install black glass tile bulkhead below storefront windows to match historic façade.
- Install new painted wood door with clear glass above solid kick plate.

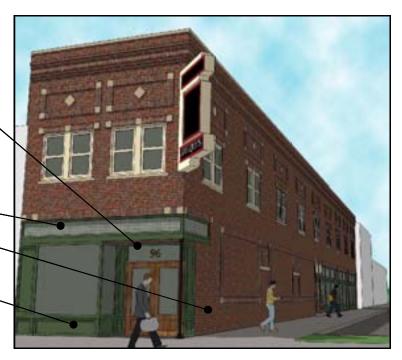
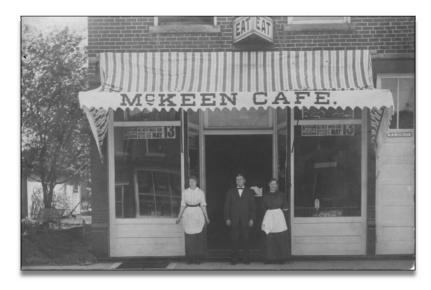
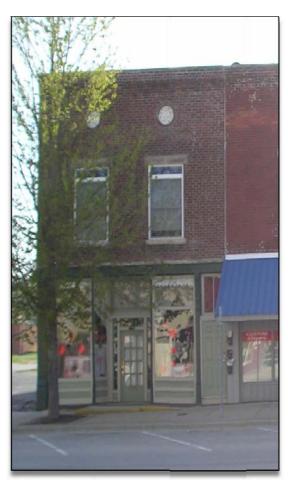
Building context and historic detail for proposed façade improvements is taken from the adjacent building, 171 North Main shown above and below, which still exhibits much of the original detailing.

- Repair attic grilles and paint.
- Remove inappropriate mortar repairs and repoint brick.
- Replace internally lit sign with double face non-internally lighted projecting sign and new hardware.
- Remove canopy that covers building details.
- Remove air conditioner above door and install in more inconspicuous location or add central HVAC system.
- Remove period inappropriate doors and replace with new two-panel doors with energy efficient clear glass.
- Remove wood façade carefully. Save original columns and reuse in existing location to recreate architecturally accurate storefront.

- Restore original columns if they exist or install painted wood columns and window frames.
- New projecting sign with two sided text in scale with the building.
- Architectural interpretation of recreated storefront is based on the original, intact, storefront to the north.
- Install energy efficient, clear window glass.
- Install painted wood bulkhead below window to match the building to the north.
- Install new solid three panel painted wood door.
- If desired, install fixed or operable canvas or mattefinish weather resistant cloth awnings. Width of awning shall fit between column lines and should not extend the full width of the storefront. Awning valance shall not be fixed or rigid.
