75-77 East Washington Street

***In-depth Building Analyses and
Recommendations***

In-depth Building Analysis Overview

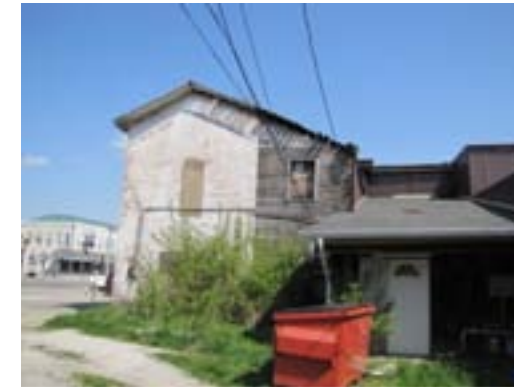
P4 – View of the rear of the building. Note the wood framed portion of the west wing addition and the one story infill addition.

- It is recommended that the wood wing of the building at the rear be completely demolished due to the poor and unsalvageable condition of the structure (see note regarding further structural study). This demolition will need to respect the one story jewelry store addition. The front wing and the west ‘L’ wing can then be rehabilitated and repaired for future usage.
- The overall strength and stability of the first floor needs to be reviewed and appropriate strengthening members put in place for retail loading. This will require a more in-depth structural study.

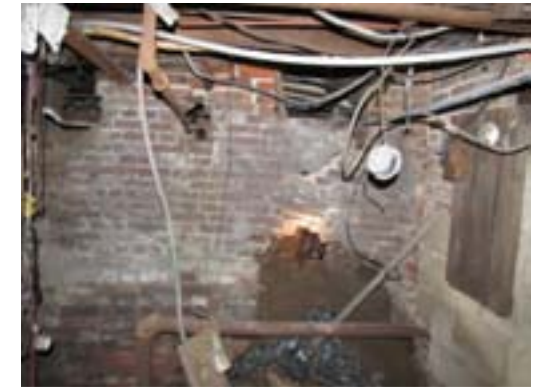
- The brick walls in the basement are in poor condition in many areas. The basement is very wet and the brick retaining walls have suffered partial collapse in a few locations.
- On one wall in the rear wing at the south east corner of the inner boiler room between the basement and crawlspace, the brick has collapsed to a significant degree. This appears to be causing severe sagging of the first floor directly over this area.
- There are structurally unstable areas of the retaining wall on the north and south sides of the exterior stairs leading to the

- From the basement, it can be seen that the floor joists themselves are in fair condition. There does not appear to be an excessive amount of water damage.
- The floor is not level. To the rear of the pool store space, there is an area of the floor that is severely sagging, soft and spongy. This is over an area in the basement where the brick wall below is collapsed as mentioned above.

P5 – Collapsed basement wall. This occurs under the severely sagging area of the first floor.

- The collapsed walls in the basement and basement stairs need to be relayed and stabilized to provide a functioning retaining wall and provide proper joist support.
- The steel lintel over the basement wall opening should be removed and replaced. The opening can be reduced to require a shorter lintel.
- The roof framing over the west ‘L’ wing should be removed and replaced and all new decking and roofing be installed. The new roof can be profiled to accommodate the removal of the wood framed east wing.

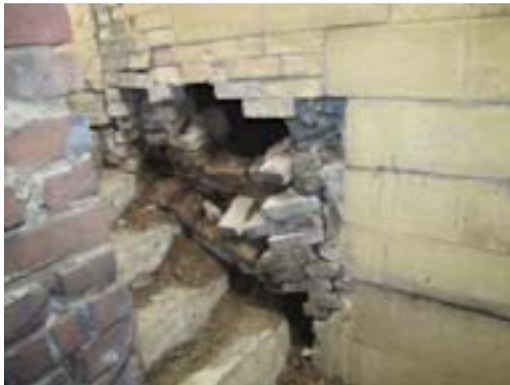
P6 – Partially collapsed block masonry on the south side of the rear stair that leads to the basement.

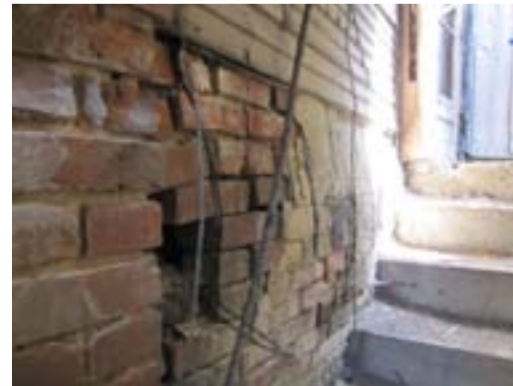
P7 – Partially collapsed and bowing brick masonry on the north side of the rear stair that leads to the basement.

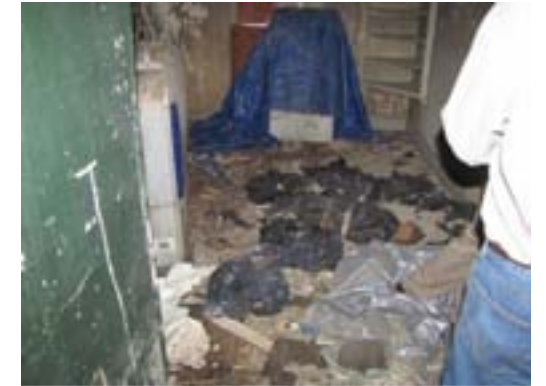
- The second floor of the ‘L’ shaped, two story portion of the building is un-level and sags in several areas. The floor should be limited to residential usage and should have a thorough structural investigation to determine the load capacity. The second floor in the rear wood framed wing of the building is in very poor condition due to water damage and deterioration.

P10 – View of the upper level floor of the wood framed addition of the west wing of the building.

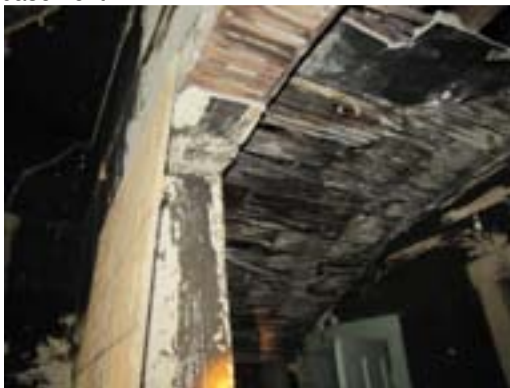
- Significant portions of the roofing over the rear wing, wood framed addition of the building are missing. This has likely resulted in water damage to the roof framing members and wood roof deck.

P11 – View of the ceiling over the upper level of the wood framed addition of the west wing of the building.

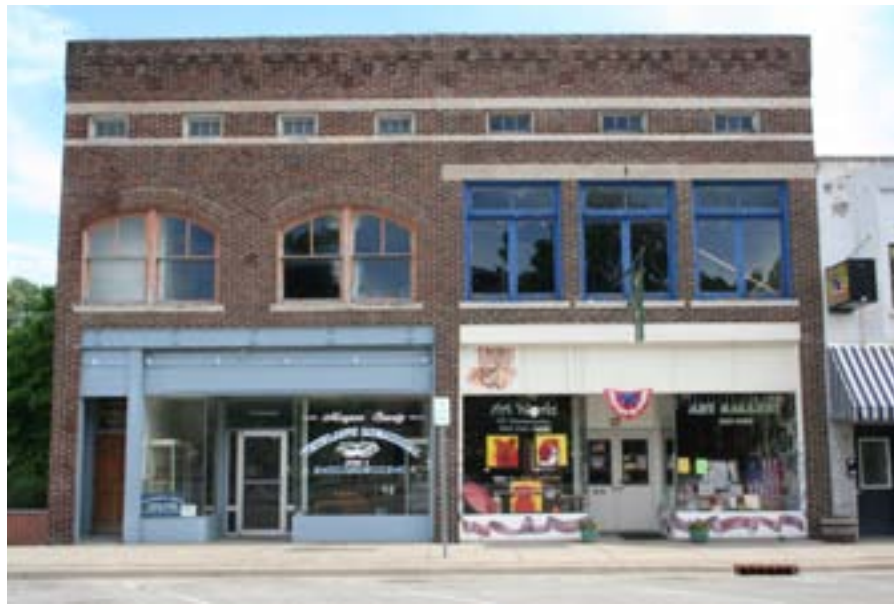
75-77 East Washington Street - North Elevation.

The moisture from the planter will cause damage to the floor joists that are embedded into the exterior masonry wall.

1. The landscape material should not come in contact with the building, and the drainage from the planters must drain away from the wall. Remove branches that contact wall. Install perforated drain tile along wall for positive drainage away from wall.
2. The plaster along the east wall is cracking and delaminating. The most economical approach to repair wall surface is to mechanically reattach the plaster and install a 1 to 1-1/2 inch EIFS over the existing plaster. *See the definition of EIFS in the Façade Assessment & Improvement Recommendations Overview, page 43.* Install a new metal coping at the top of the parapet wall.

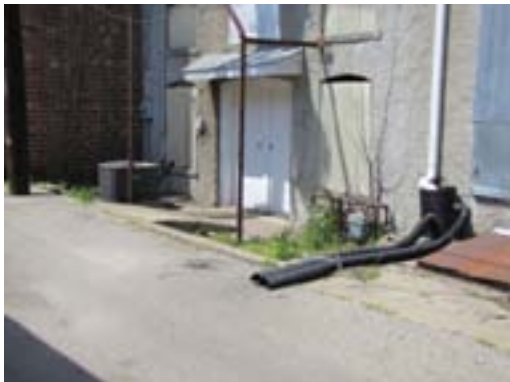
- Along the rear of the building, the existing grade is lower than the adjacent alley. This condition is likely the main source of water leakage into the basements. Water may be getting into the VM basement along the east side of the building as well.
- There appears to be a brick wall along the length of the crawlspace that supports the floor joists at mid-span in both the art store and VM.

P6 – Close-up of the rear of the building. Note the low grade against the building.

- The low finish grade in the rear of the building is contributing to water leakage in the basement. This condition should be studied and corrected as soon as possible to prevent further water leakage in the basement. The stair leading to the basement on the museum side of the building and the abandoned coal chute on the art store side should be closed off and filled in to eliminate this point of entry for water leakage. An access stair to the basement from the VM should be built internally.
- The wood beam supporting the first floor joists in the VM should be modified and intermediate steel jack posts added to increase structural floor capacity to 100 psf.
- The water damaged joists at the first floor of the VM should be removed and replaced.

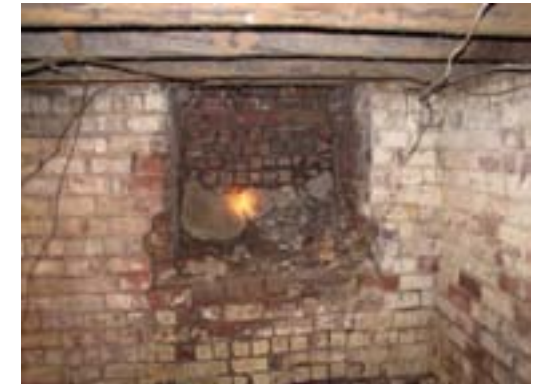
P10 – Abandoned coal chute in the south basement wall under the art store. This is one point of entry for water.

Repair improper drainage in alley by removing old coal chute and raising finish grade near building to shed storm water away from building. Either connect downspout drains to city storm sewer system or direct water to street and away from building foundations. Remove exterior stair to basement and fill opening in foundation. Waterproof entire below grade wall before backfilling. Install new stair to basement inside building.

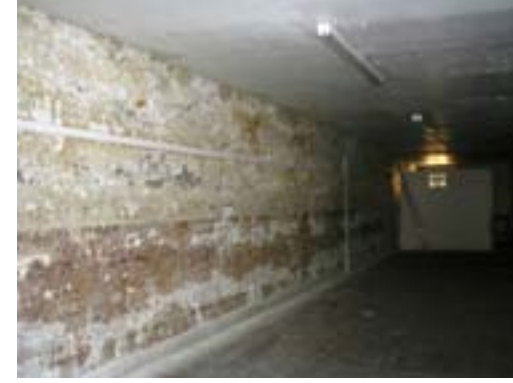
P14 – Close up view of the second floor, east wall of the building. This wall was exposed to fire in the past.

- The east wall of the building was exposed to fire according to a past report. If an examination and assessment of this wall has not already been made, such a study should be considered.

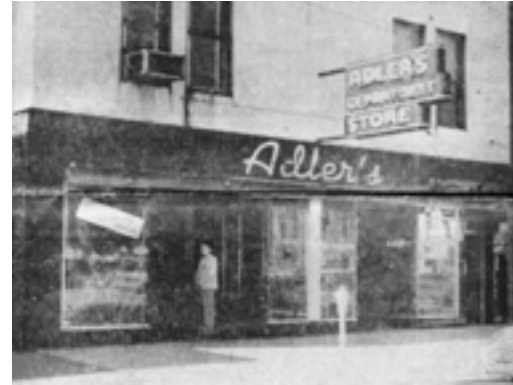
P2 - 1959 photo of the front of the building. Tenant was Adler's Department Store.

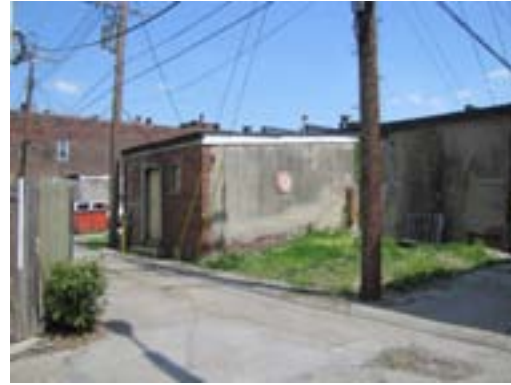
P3 - Rear of the building. Note the smaller projecting addition on the western-most end of the building.

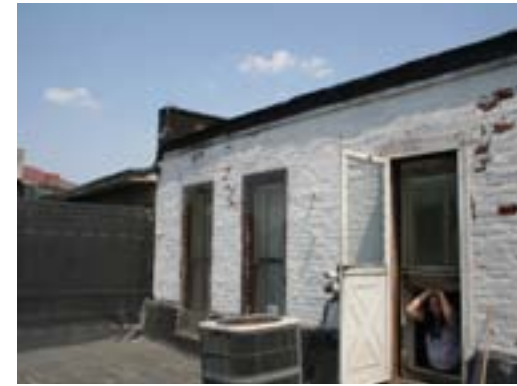
- There was noticeable water leakage and some masonry damage on the inside of the rear, upper exterior wall. This wall bears on a steel beam as described above. The water leakage appears to be the result of roof leaks and leaks around the windows.

P9 - Upper level exterior masonry wall at the rear of the two story wing. View of the outside face of the wall.

- The basement should be cleaned out and abandoned pipes and mechanical equipment removed to create a less hazardous basement area.
- The second floor of the two story wing should be thoroughly checked for future residential occupancy loading.
- The double steel beam supporting the rear, upper exterior masonry wall should be exposed and examined for the presence of corrosion that might reduce the beam capacity. This is needed because of the observed water leakage in this wall at the second floor.

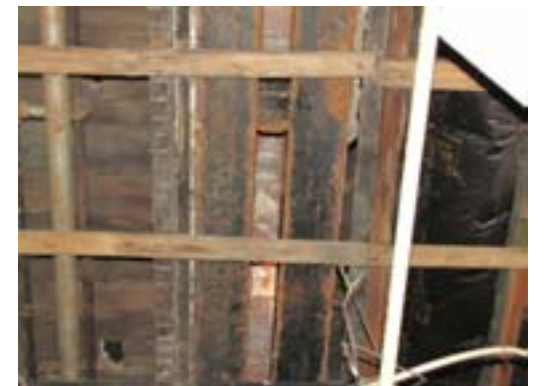
- Some minor rust was noted on the bottom of the double beam that supports the rear, upper exterior wall.

P10 - Bottom of the double steel beam supporting the upper masonry wall at the rear of the two story wing.

- The overall load capacity for the first floor should be determined for comparison to retail code loading.
- The steel beam supporting the upper brick wall should be examined to determine if corrosion has occurred from water leakage.

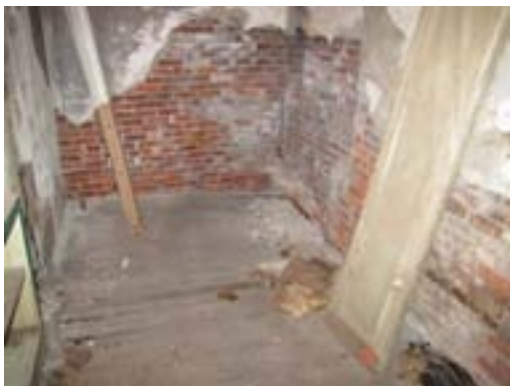
- There are two floor areas observed that are sagging and spongy. These areas cannot support even modest load. These areas sag noticeably when supporting the weight of a person. Both of these areas are on the south side of the first floor, one in the two story wing and the other in the one story wing.

P11 - Spongy and sagging floor area at the south side of the first floor.

- It is recommended that the wood floor framing in the spongy areas of the first floor be removed and replaced with new floor joists and new wood floor deck. Extent of the replacement to be field verified.
- The overall strength and stability of the first floor needs to be reviewed and appropriate strengthening measures put in place for retail loading, if required. This will require a more in-depth structural study.
- Remove and replace the roof framing over the rear one story projecting addition wing as required. Field verify the extent of the work needed.

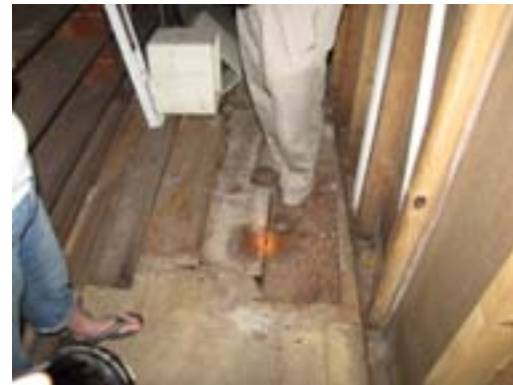
P12 - Spongy and sagging floor area at the south side of the first floor.

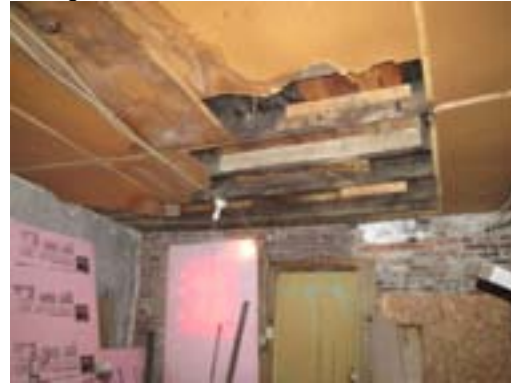
P13 - View of the roof framing over the rear projecting one story addition. Note the structural modifications.

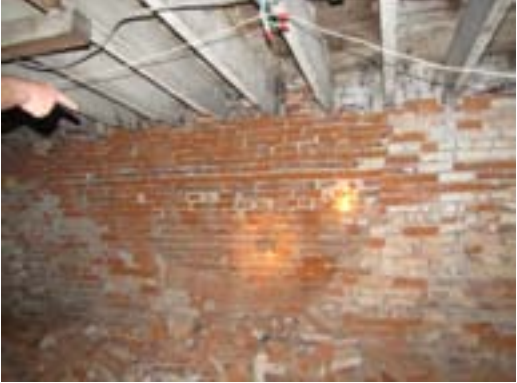
P5 - Collapsed cistern in the basement within the front compartment.

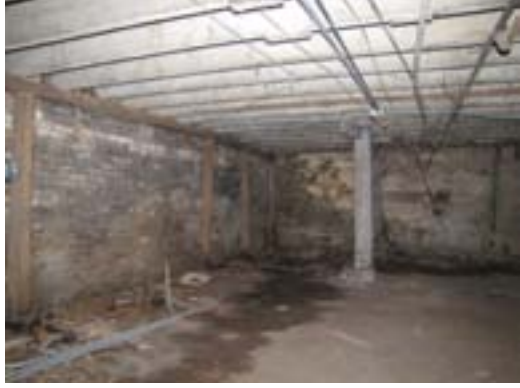
- From the basement, it can be seen that there are several areas where the first floor joists are supported on added wood post and beams. It appears that the joists were originally intended to span the width of the basement which is about 18'-8" from side wall to side wall.
- An estimate of the floor live load capacity, depending on the wood properties assumed, is about 50 to 60 psf. This is inadequate for retail occupancy which requires 100 psf.
- The floor is not level and is lower at the north side compared to the south side.
- An area of the floor on the west side in front of the door opening is very soft. The support below is weak.
- In the rear basement compartment, there are several areas where wood post and beam supports have been added.

P8 - Rear compartment of the basement. Note the wood posts and beams providing additional floor joist support.

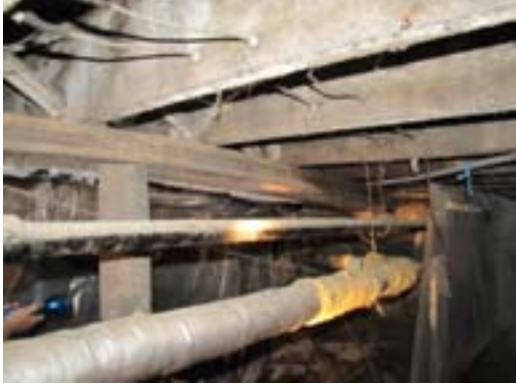
P9 - Rear compartment of the basement. Note the wood posts and beams providing additional floor joist support.

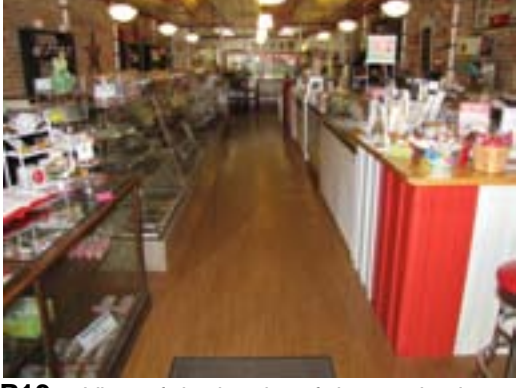
P13 - View of the interior of the candy shop looking west.
